# Manhole Inspection Summary

Manhole # S13GG\_050MH

Insp Date: **2/23/09 2:29 PM**

**Location** Address: **1641 POPLAR GROVE DR**

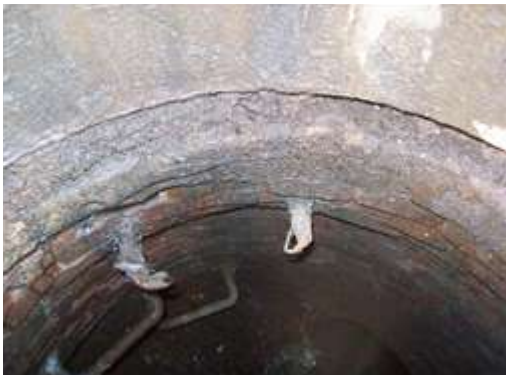
Defect 3

Count: **3** Missing: **1** ☒ **Corroded**

CORRODED STEP

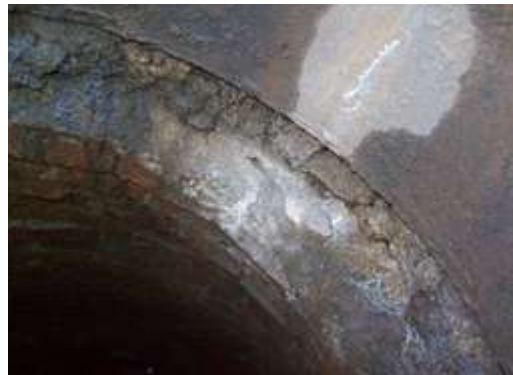
Defect 2

Condition: ☐ Sound ☐ Cracked ☐ Root Intrusion ☐ Loose Brick ☒ **Deteriorated**

CHIMNEY DETERATION

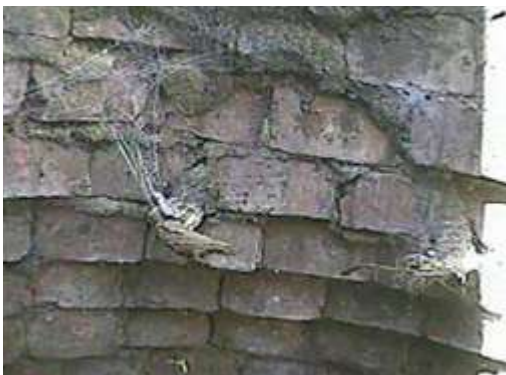
Defect 1

MISSING/CORRODED RUNG

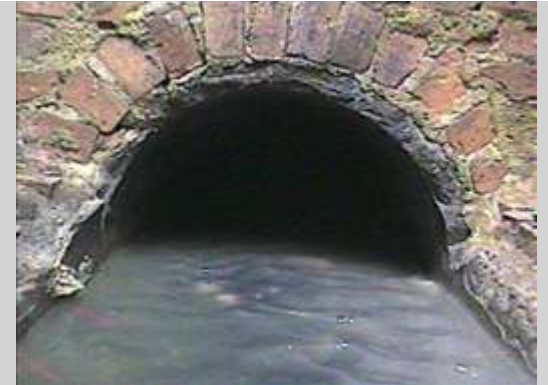
12 O'Clock Outflow

18 in. Circular Gravity Sewer  
Pipe Out @ 12 O'Clock

Pipe Height: (in.) Direct  
Pipe Material: **Clay** ☐ Pipe Lined  
Invert Depth: **6.40** (ft.) Flow Characteristics: **Slow**  
Deposits: ☒ None ☐ Mud ☐ Sludge ☐ Debris ☐ Grease  
Silt Depth: (in.) Deposits Extent:  
Infiltration: **None** Pipe Seal Cond: **Broken**

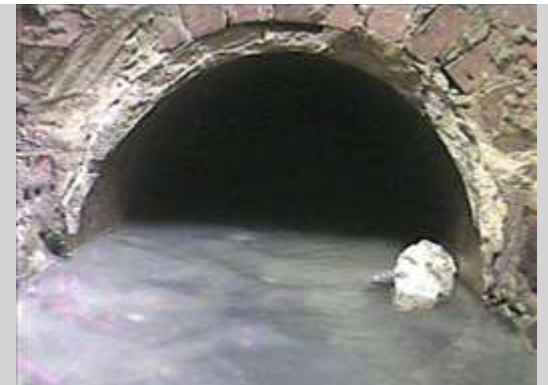
6 O'Clock Inflow

18 in. Circular Gravity Sewer  
Pipe In @ 6 O'Clock

Pipe Height: (in.) Direct  
Pipe Material: **Clay** ☐ Pipe Lined  
Invert Depth: **6.38** (ft.) Flow Characteristics: **Slow**  
Deposits: ☒ None ☐ Mud ☐ Sludge ☐ Debris ☐ Grease  
Silt Depth: (in.) Deposits Extent:  
Infiltration: **None** Pipe Seal Cond: **Broken**
